## Case report

# Third degree skin burns caused by a MRI conditional electrocardiographic monitoring system

Lau Brix<sup>1,2,\*</sup>, Christin Isaksen<sup>2</sup>, Birgitte Hornbæk Kristensen<sup>2</sup>, Donika Tufa<sup>2</sup>

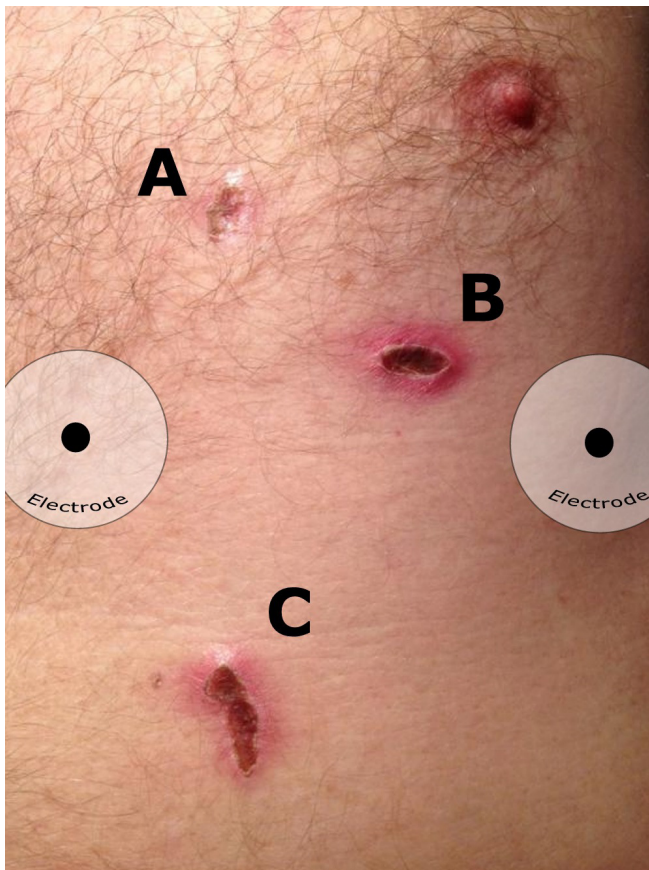
The first case was a 74-years-old male (body weight 90 kg). The patient was referred to an MRI due to postoperative complications related to his lumbar spine. Figure 2 shows three elongated burn lesions caused by heating one week after the MRI. The wounds are covered with crusts and surrounded by reddened, inflamed skin and are therefore no longer in the acute phase. This is consistent with the time of injury one week prior to the image recording. The wounds are oriented in a zig zag pattern between the electrodes (as indicated by the graphical overlay), which indicates trauma caused by the ECG leads instead of the ECG electrodes. The skin of the patient was not particularly sweaty and two of the three burn wounds were placed on areas without much body hair.

**Figure 2** Case 1: Image of skin burns caused by ECG leads. Placement of the electrodes is indicated by the graphical overlay. The image is dated one week after the MRI scan and demonstrates three elongated burn lesions caused by heating (A, B & C). The lesions are covered with crusts and surrounded by reddened, inflamed skin and are therefore no longer in the acute phase which is consistent with the time of injury. The wounds are oriented in a zig zag pattern between the electrodes, which indicates trauma caused by the ECG leads instead of the ECG electrodes.

sedated locally with EMLA® (AstraZeneca, active drugs are lidocain and prilocain) before cutting the necrotic tissue with a scalpel. Hereafter the wounds were treated by Aquagel Ag Hydrofiber® and a foam bandage.

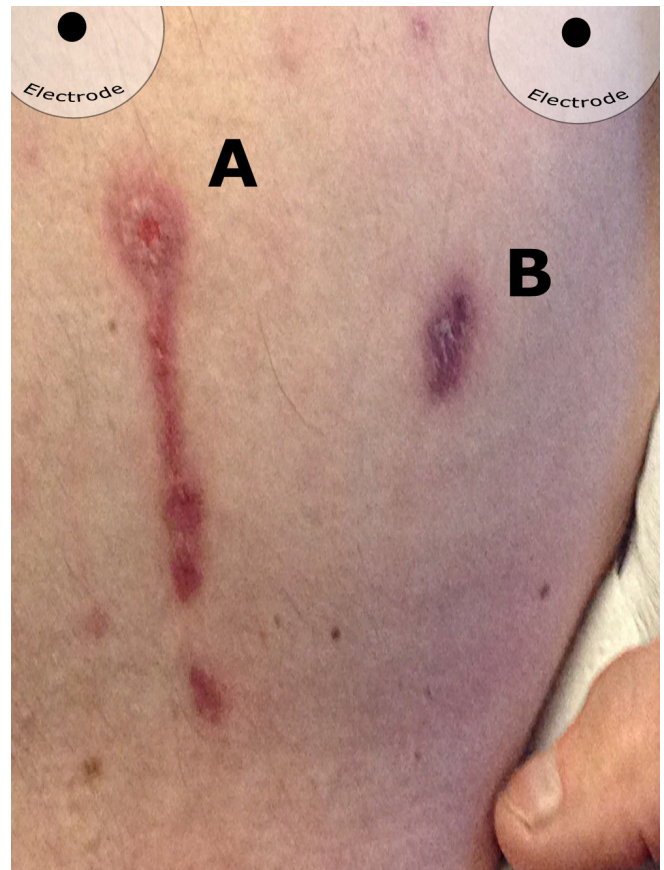
The second case was a 59-years-old male (body weight 100 kg). He was MRI scanned due to a suspected lumbar prolapse. Figure 3 demonstrates two elongated burn lesions caused by heating during healing. The image is dated two weeks after the MRI scan which is consistent with the time of injury. The wounds are oriented in between the electrodes (as indicated by the graphical overlay) and indicates trauma caused by the ECG leads. The skin of the patient was not sweaty and the two acquired burns were placed on areas without any body hair. Even though the patient suffered from 3rd degree burns, no medical or surgical intervention was performed.

**Figure 3** Case 2: Image of skin burns caused by ECG leads. Placement of the electrodes is indicated by the graphical overlay. The image is dated two weeks after the MRI scan and demonstrates two elongated burn lesions caused by heating (A & B) during healing which is consistent with the time of injury. The wounds are oriented in between the electrodes, which indicate trauma caused by the ECG leads instead of the ECG electrodes.
