# Third degree skin burns caused by a MRI conditional electrocardiographic monitoring system

## Abstract

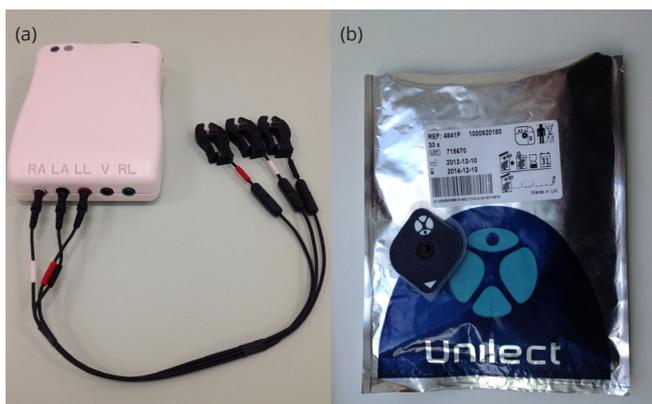
**Figure 1** (a) Three lead electrocardiogram module box which is connected to a Medrad® Veris MR Monitor (Bayer HealthCare AG, Leverkusen, Germany). The leads are connected to the ECG box and the box is connected to the main monitoring unit using an optical cable; (b) The MRI conditional electrodes (Unilect™ 4841P ECG electrodes, Unomedical Ltd., Stonehouse, Great Britain).

inspected and found to be in working condition (tears and electrode gel). Bayer Quality Assurance Product Analysis reviewed the complaint record and pointed towards four observations of use error: no skin preparation gel was used on the patients, applications of non-recommended electrodes, placement of the ECG module within the imaging plane and missing insulation of the ECG leads from the patient's skin. In this context, the applied electrodes are MRI conditional up to 3T and have been used for several years at 1.5T and at 3T at our institution. As no wounds were seen under the electrodes, we do not believe that the thermal injuries were caused by the electrodes or by absence of electrode gel. Furthermore, BHCD recommends to physically position the ECG module (white box on Figure 1) out of the imaging plane as neglecting this may contribute to heating of the leads and electrodes due to the 'antenna effect' (4;12). As the module was in fact placed within the imaging plane, this may in theory have lead to the incidents.

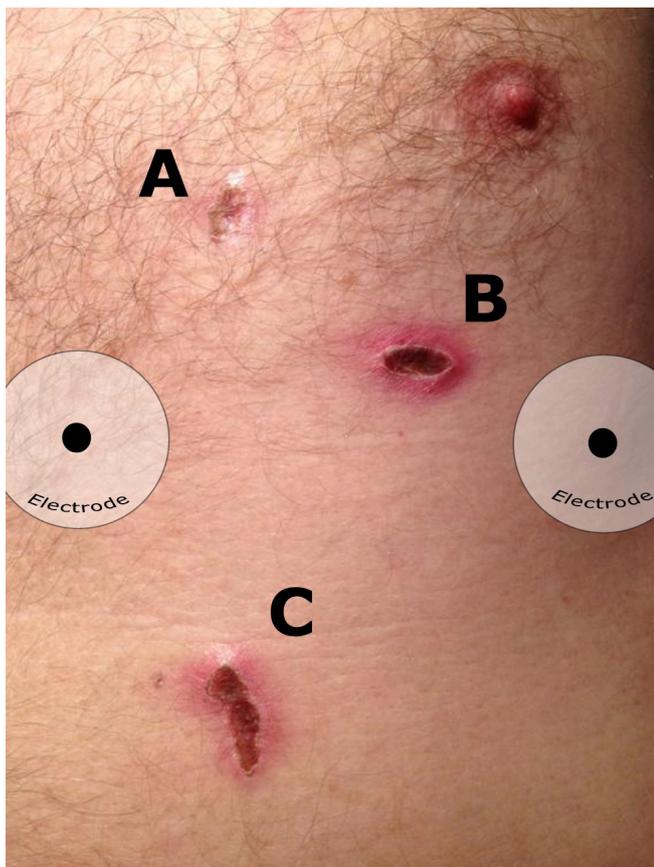
The first case was a 74-years-old male (body weight 90 kg). The patient was referred to an MRI due to postoperative complications related to his lumbar spine. Figure 2 shows three elongated burn lesions caused by heating one week after the MRI. The wounds are covered with crusts and surrounded by reddened, inflamed skin and are therefore no longer in the acute phase. This is consistent with the time of injury one week prior to the image recording. The wounds are oriented in a zig zag pattern between the electrodes (as indicated by the graphical overlay), which indicates trauma caused by the ECG leads instead of the ECG electrodes. The skin of the patient was not particularly sweaty and two of the three burn wounds were placed on areas without much body hair.

**Figure 2** Case 1: Image of skin burns caused by ECG leads. Placement of the electrodes is indicated by the graphical overlay. The image is dated one week after the MRI scan and demonstrates three elongated burn lesions caused by heating (A, B & C). The lesions are covered with crusts and surrounded by reddened, inflamed skin and are therefore no longer in the acute phase which is consistent with the time of injury. The wounds are oriented in a zig zag pattern between the electrodes, which indicates trauma caused by the ECG leads instead of the ECG electrodes.

The Applied Turbo Spin Echo [13] imaging sequence utilizes many RF pulses in rapid order which may have raised the RF deposition for short periods of time as indicated by the SAR values stated above. In this relation, SAR limits are calculated as the average over 6 min and the operator must accept that the following imaging sequence will be raised above the 2 Watts/kg standard level. This is also known as first-level scanning. As the extension of the burns converge

with the location of the leads, we therefore assume that the burns were caused by the direct skin contact with the leads and a marginal crossing of the assigned compatibility specifications of the leads. Furthermore, if the leads had been supported by a foam spacer or similar to avoid direct skin contact, the heating of the lead may not have caused the injuries. In this context, the placement of the ECG leads, with no distance separating the cables from the patient's skin have been the standard practice on our Siemens Avanto 1.5 Tesla MRI system for several years. No incidents have occurred using that practice. As we only have access to one MRI conditional ECG monitoring system (and one type of electrodes), the personnel is very familiar with the system. However, in rare cases we allow level 1 imaging on the 1.5T system for the patient group reported in this case report without experiencing any problems. Thus, the monitoring system was well known, thoroughly tested at 1.5T (including the leads and electrodes) and marked as MRI conditional. Moving the examination of the patients to 3T, using the same practice as on the 1.5T may have been the catalyst of the thermal injuries.

After detection of the burns, the patient was treated by removing crust of necrotic tissue. The wounds were

sedated locally with EMLA® (AstraZeneca, active drugs are lidocain and prilocain) before cutting the necrotic tissue with a scalpel. Hereafter the wounds were treated by Aquagel Ag Hydrofiber® and a foam bandage.

MRI scanning of sedated patients calls for special attention from healthcare professionals as the patients cannot cry out in the event of extreme heating which may lead to skin burns. Using MRI conditional ECG equipment may still cause patient skin burns if precautions are not taken. The guidelines below should minimize the risk of ECG monitoring related skin burns in the future: (a) always use an ECG monitoring system which is MRI conditional, (b) ensure that the applied ECG electrodes are approved for the type of MRI system being used, (c) ensure that a gap is established between the ECG leads and the patient's skin (using a cloth or a foam spacer), (d) avoid any looping of the wires to avoid induction of electrical current and (e) be very cautious when accepting first-level scanning even when MRI conditional ECG equipment is being used.

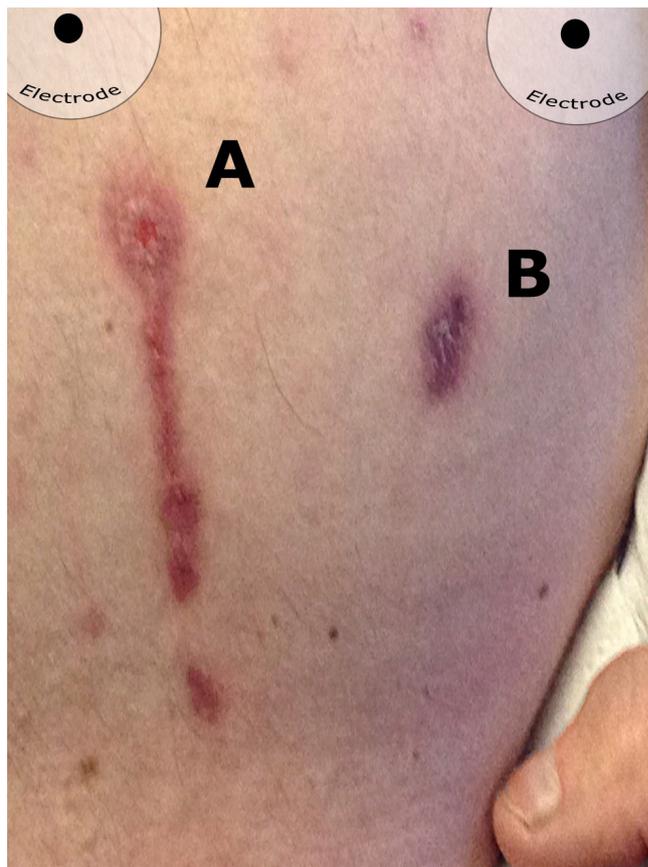
The second case was a 59-years-old male (body weight 100 kg). He was MRI scanned due to a suspected lumbar prolapse. Figure 3 demonstrates two elongated burn lesions caused by heating during healing. The image is dated two weeks after the MRI scan which is consistent with the time of injury. The wounds are oriented in between the electrodes (as indicated by the graphical overlay) and indicates trauma caused by the ECG leads. The skin of the patient was not sweaty and the two acquired burns were placed on areas without any body hair. Even though the patient suffered from 3rd degree burns, no medical or surgical intervention was performed.

**Figure 3** Case 2: Image of skin burns caused by ECG leads. Placement of the electrodes is indicated by the graphical overlay. The image is dated two weeks after the MRI scan and demonstrates two elongated burn lesions caused by heating (A & B) during healing which is consistent with the time of injury. The wounds are oriented in between the electrodes, which indicate trauma caused by the ECG leads instead of the ECG electrodes.
