## Case report

# Third degree skin burns caused by a MRI conditional electrocardiographic monitoring system

Lau Brix<sup>1,2,\*</sup>, Christin Isaksen<sup>2</sup>, Birgitte Hornbæk Kristensen<sup>2</sup>, Donika Tufa<sup>2</sup>

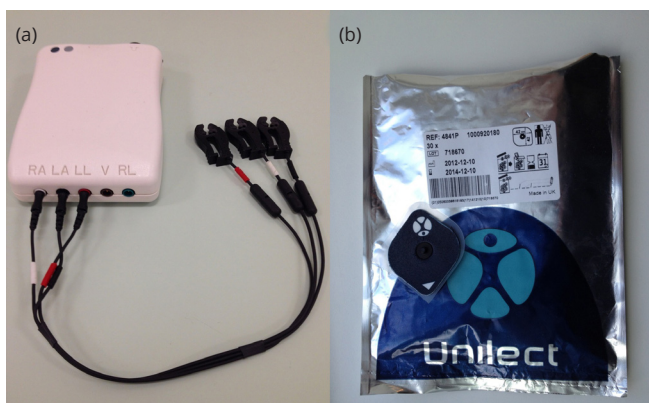
**Figure 1** (a) Three lead electrocardiogram module box which is connected to a Medrad® Veris MR Monitor (Bayer HealthCare AG, Leverkusen, Germany). The leads are connected to the ECG box and the box is connected to the main monitoring unit using an optical cable; (b) The MRI conditional electrodes (Unilect™ 4841P ECG electrodes, Unomedical Ltd., Stonehouse, Great Britain).

The electrodes are labeled MR conditional by the manufacturer for magnetic field strengths up to 3.0 Tesla if the SAR is kept below 2 Watts/kg. The electrode manual states that this relates to a temperature increase of 2.3°C during 15 min a continuous scanning in a non-clinical test assessed by calorimetry. The ECG monitoring system is
